Pits and Impoundments Final Report

Assessing Environmental Impacts of Horizontal Gas Well Drilling Operations (ETD-10 Project)

Prepared for:

December 17, 2012

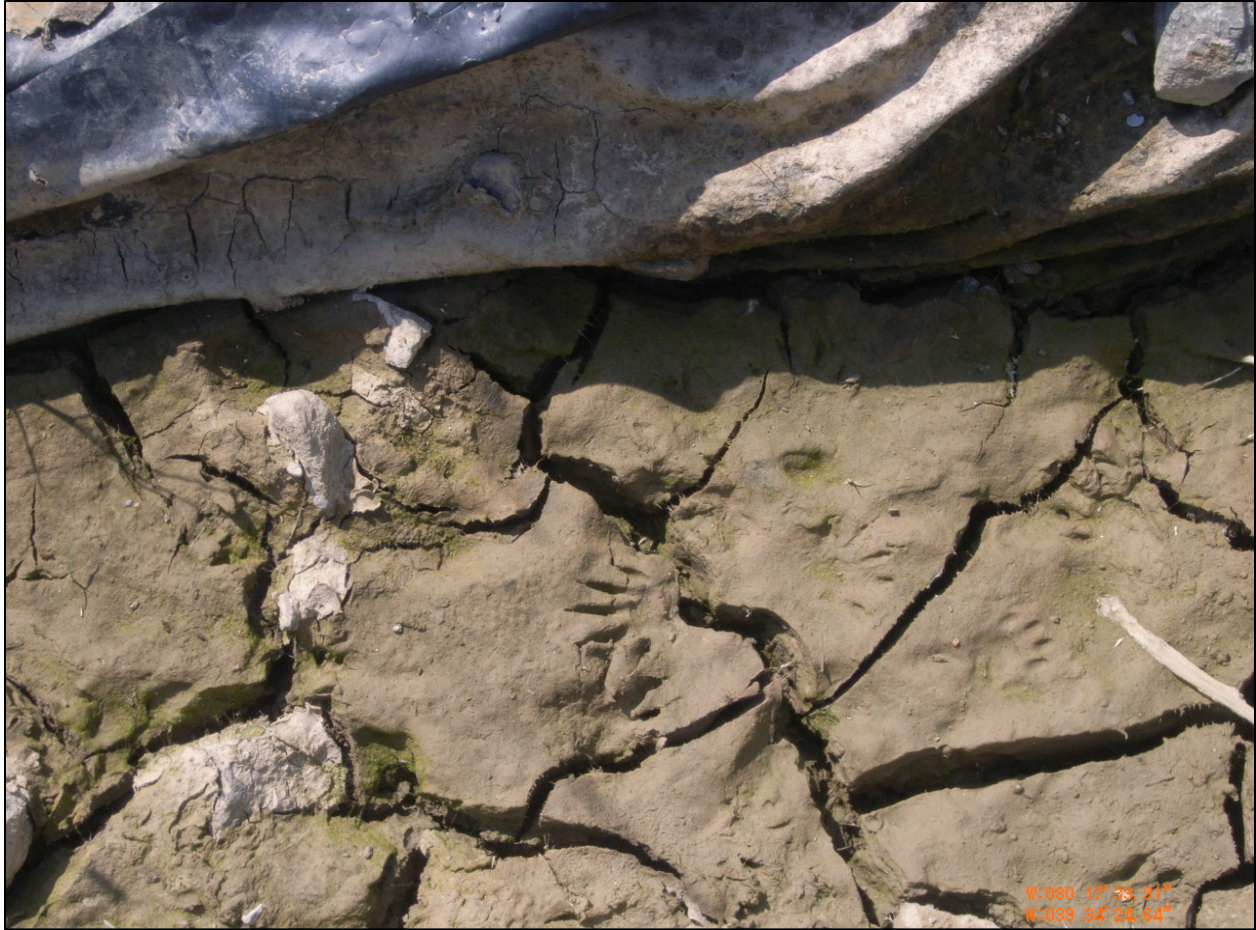
Figure 4: Settlement Cracks in Anchor Trench

Figure 4 shows settlement cracks on the crest of the impoundment around the anchor trench. The significance of this observation is that these cracks can serve as pathways for water to infiltrate and saturate the soil. The wet soil adds weight to the top of the slopes and is a recognized mechanism for surface water infiltration leading to slope instability.

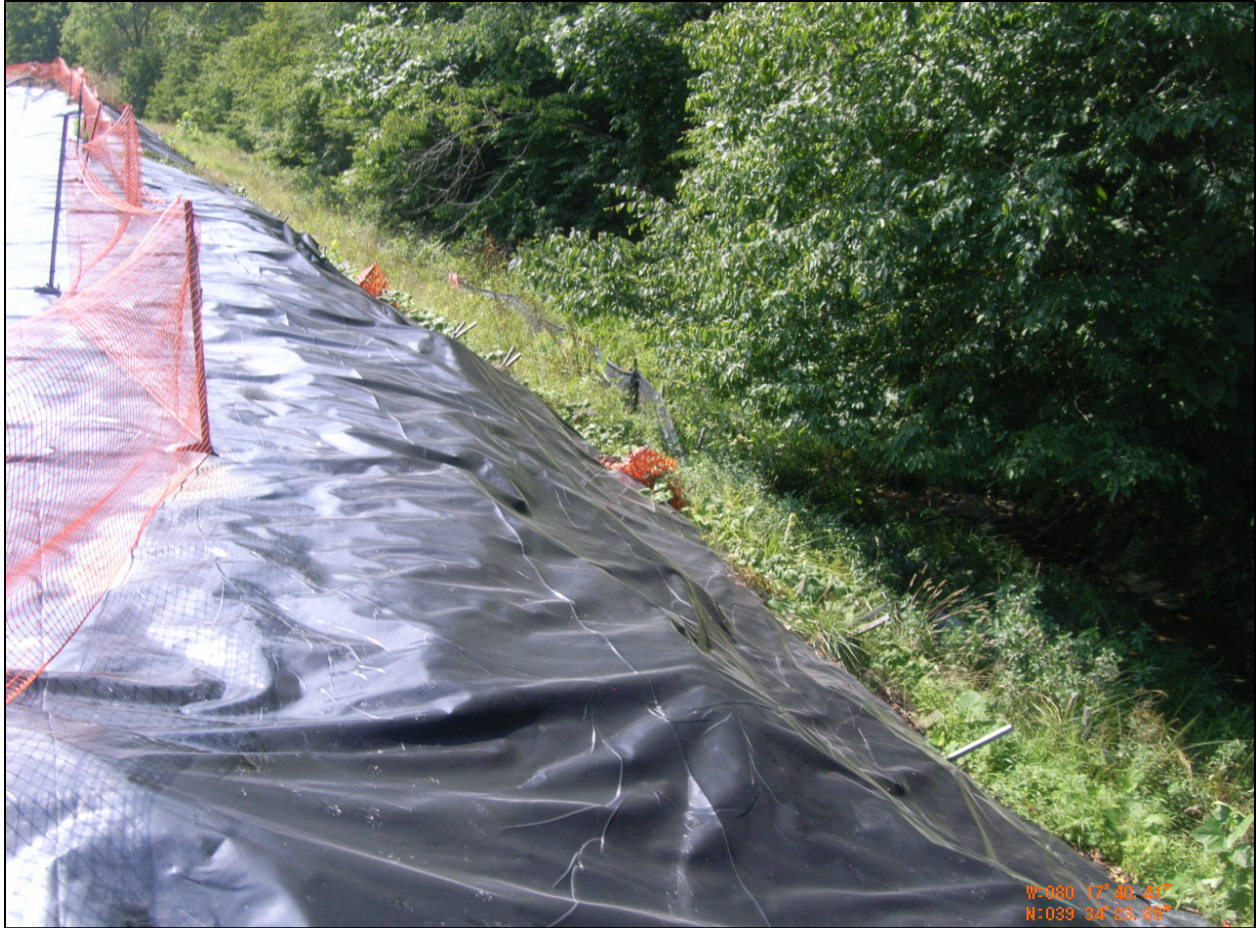
Figure 5: Bulges on Downstream Face

In Figure 5, the bulges underneath the liner indicate slope movements on the downstream face. The slope movements are evidence that the slope is no longer stable and that the ability for the structure to retain fluid has been compromised.

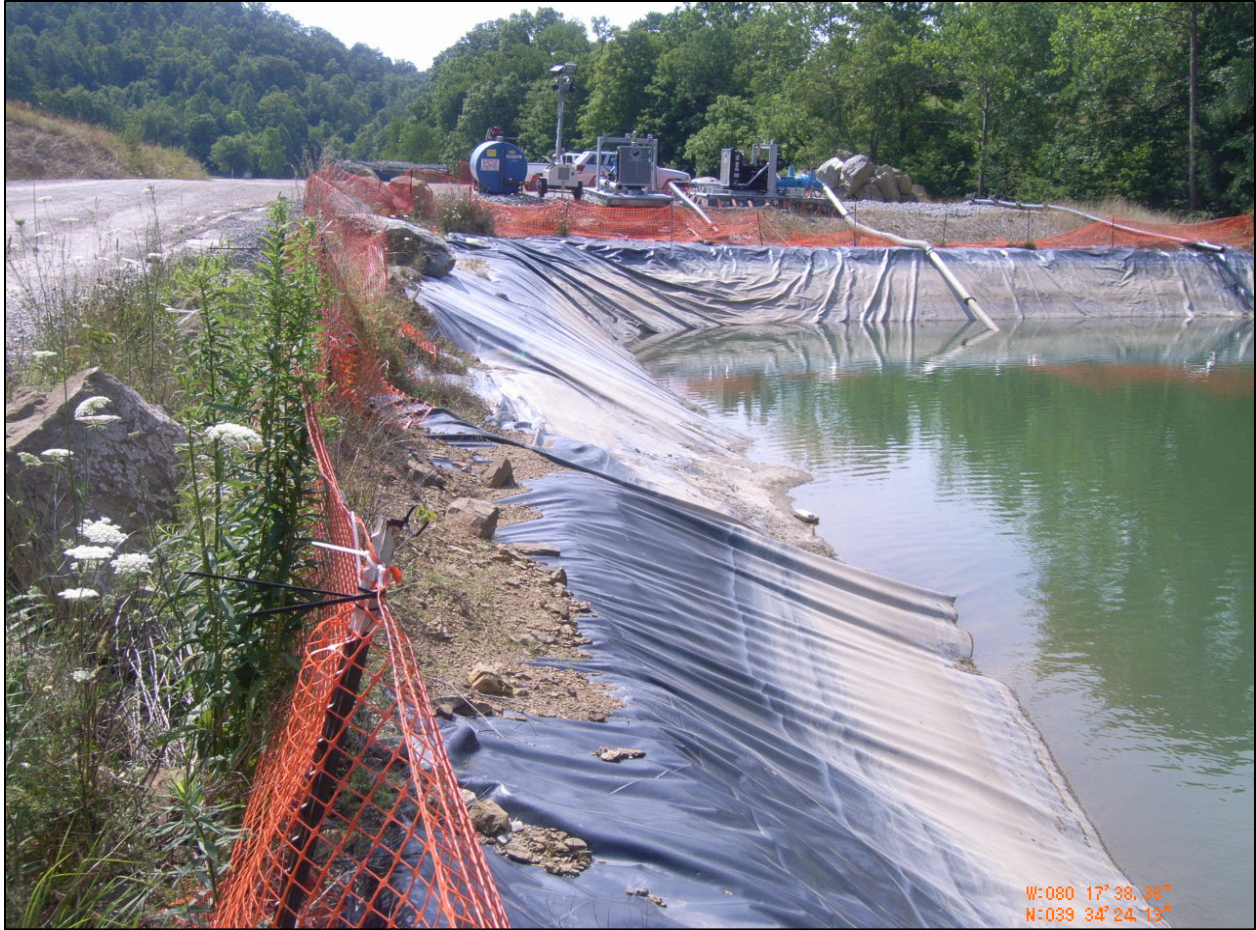
Figure 8: Rock and Debris on Liner

In Figure 8, a high amount of soil and rock is present on the liner, including a large boulder in danger of sliding into the impoundment or puncturing the liner. A possible consequence related to this problem is that the rock and debris add weight to the liner, straining the embedment of the anchor trench and posing a hazard to the containment system.

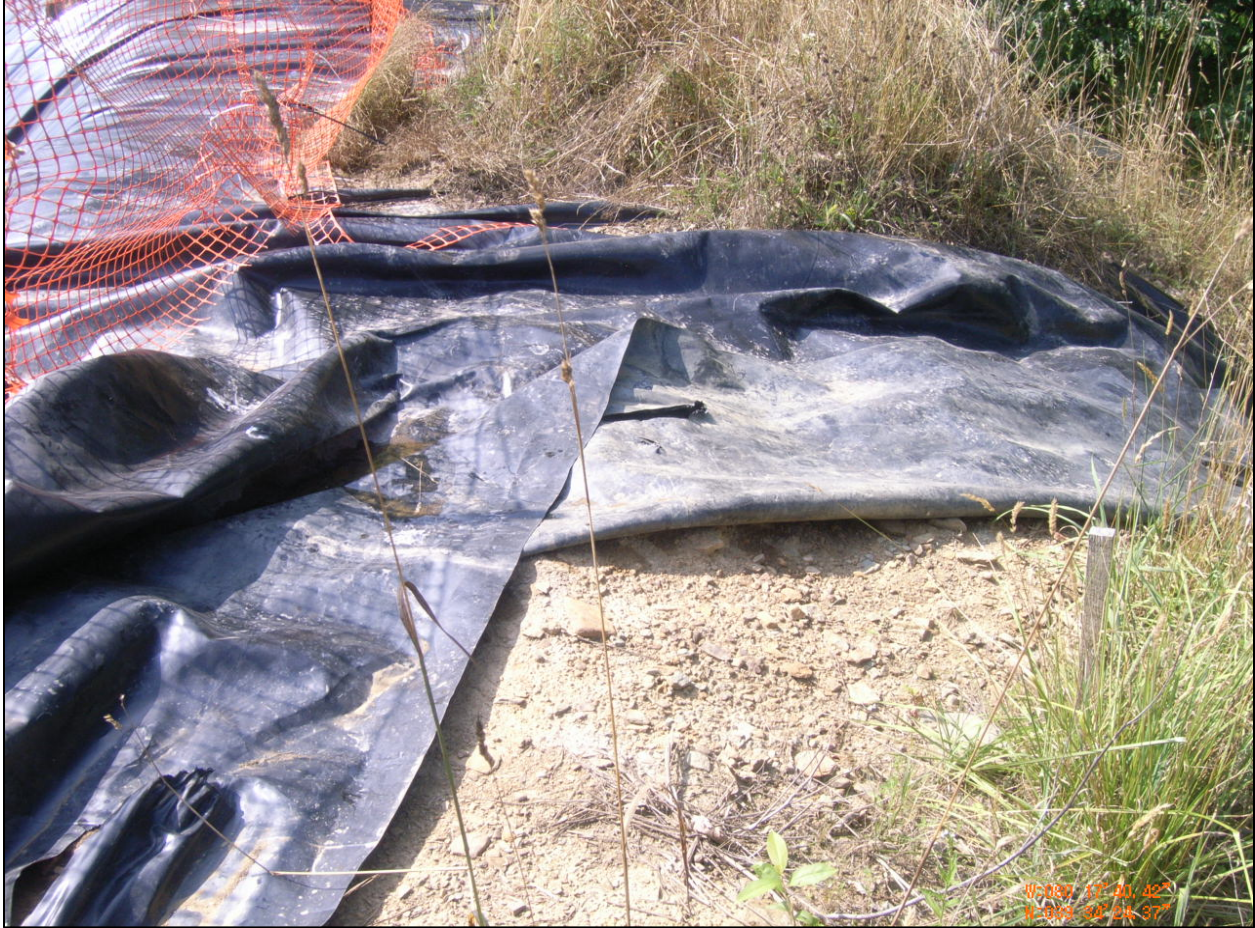
Figure 9: Anchor Trench Exposed

Figure 9 illustrates an improper anchor trench for the liner. With the liner exposed, the potential for wind uplift is greatly increased, which could lead to displacement of the liner and possible failure of the containment system.

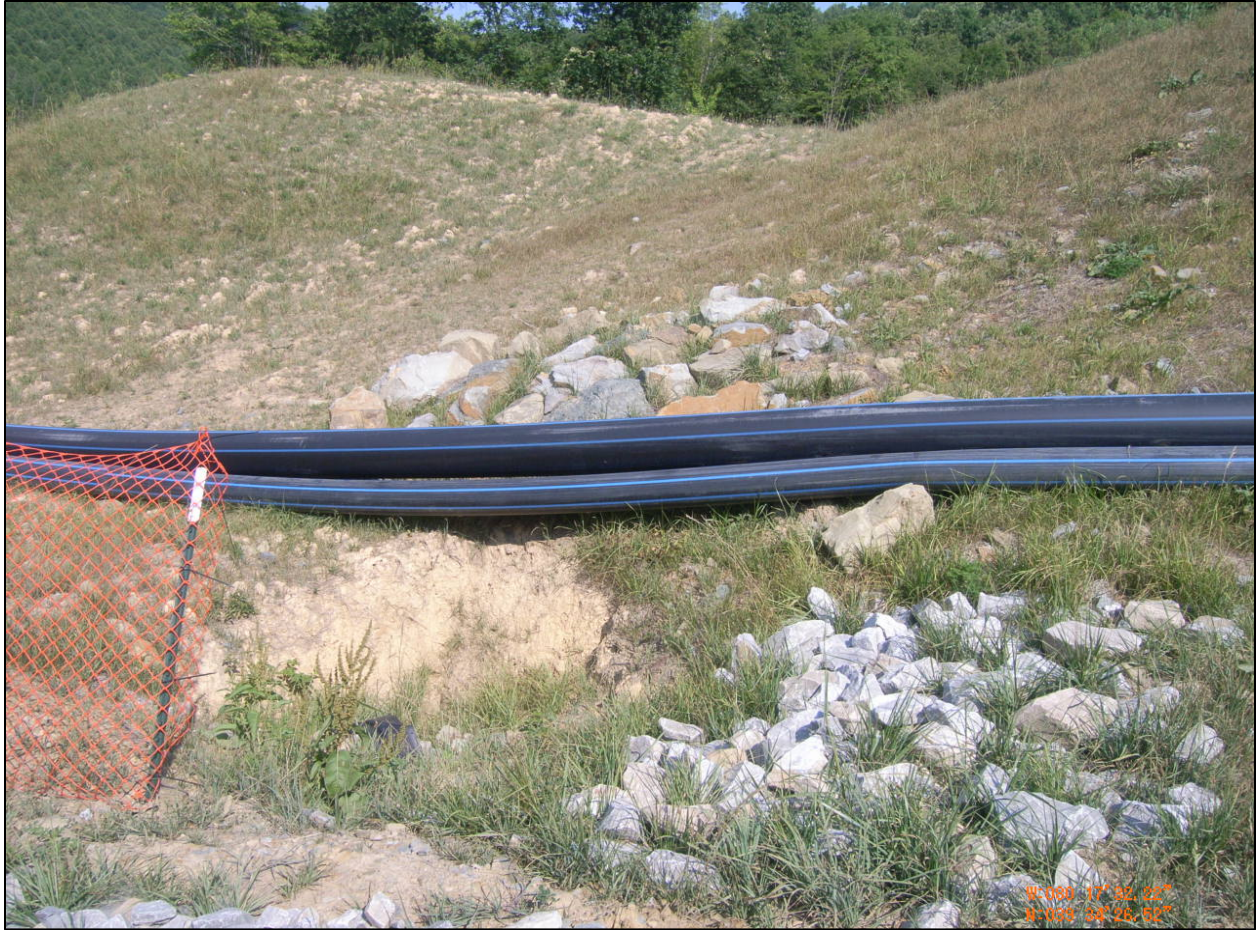
Figure 10: Unsupported Pipe

Figure 10 shows unsupported pipes along the hillside above the access road. Due to this placement, there is a greater likelihood of damage to the pipes that may lead to leakage and uncontrolled release of liquids. Any leakage or rupture of the pipes which convey water or flowback fluids would have an environmental impact to the surface water and groundwater.

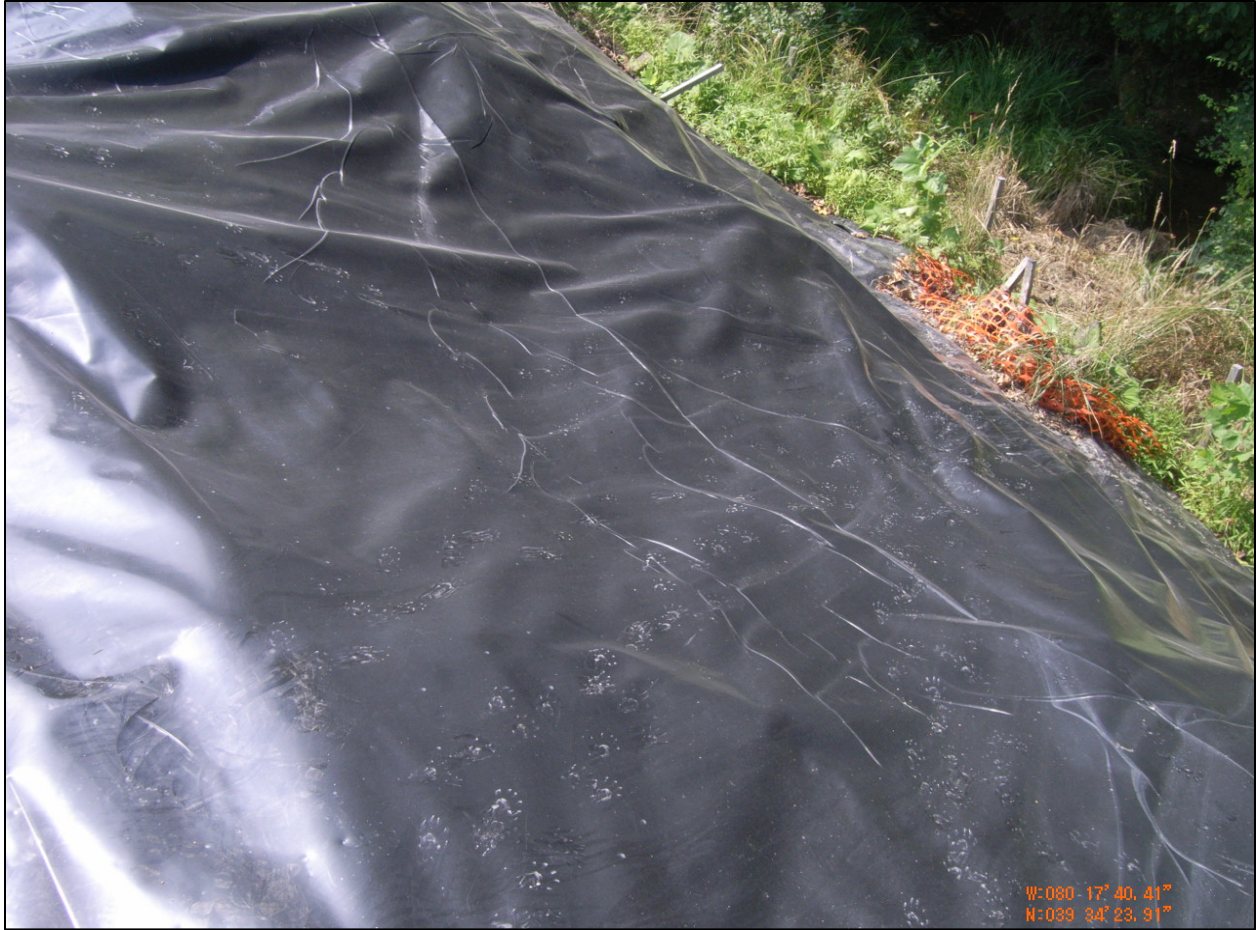
Figure 11: Downstream Slope Movement into Ditch

Figure 11 depicts a downstream slope movement, as evidenced by the bulges underneath the liner and the movement of the grade stakes. A stream is located at the top right-hand corner of the picture. Thus, the slope movement is encroaching on the stream and threatening to disrupt the natural ecosystem.

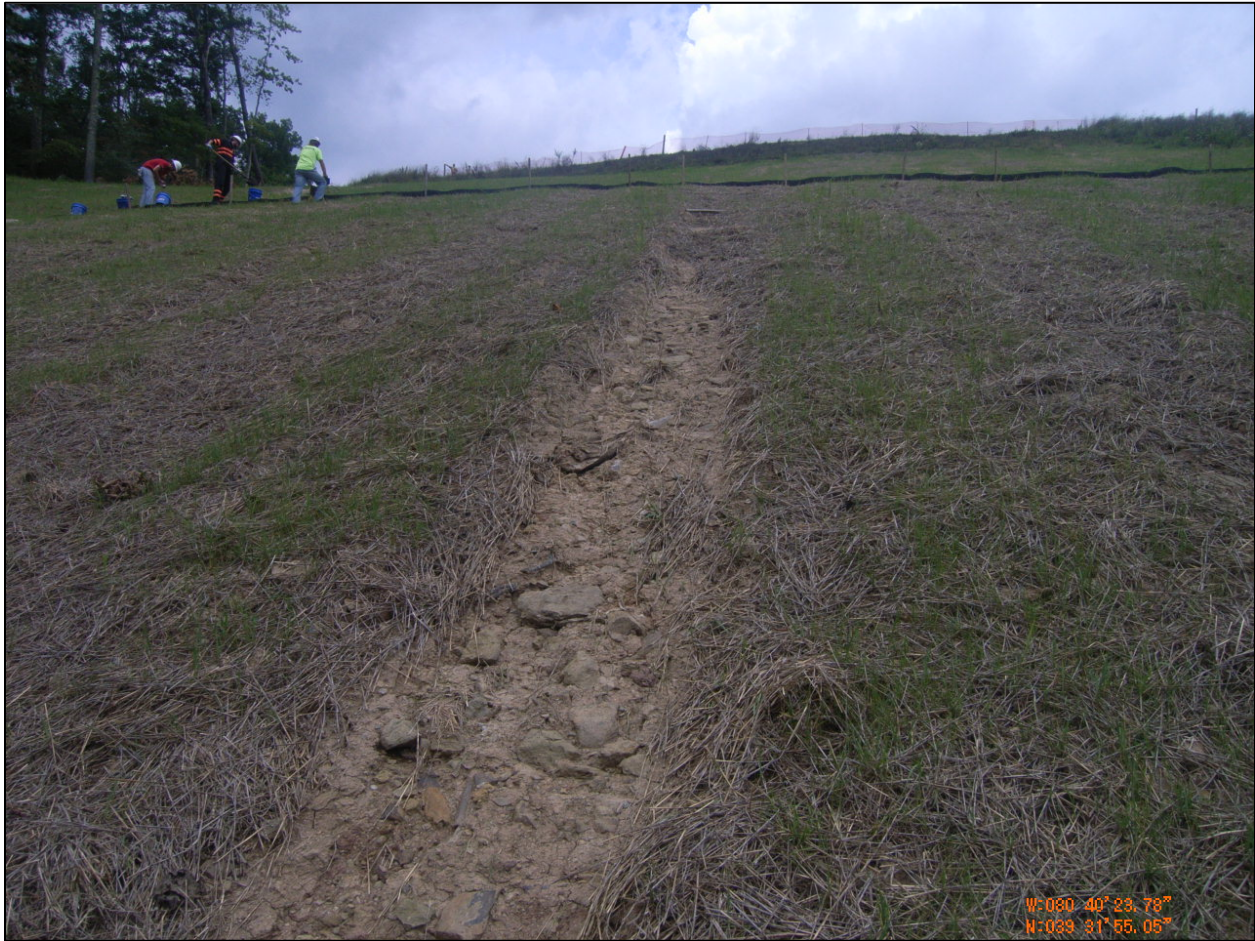
Figure 12: Surface Erosion at Mills-Wetzel

One problem area observed at all sites was surface erosion, found in Question 1 on the observation checklist. This problem was the most observed and, hence, received the lowest average ranking of 2.00. Figure 12 shows an example of the surface erosion present at the Mills-Wetzel Freshwater Impoundment. The gully shown formed rapidly, as evidenced by the lack of vegetation. The formation of the gully may be a result of excessive slope length or angle on the downstream face. The West Virginia Erosion and Sediment Control Field Manual states that terracing shall be constructed for each additional 50 vertical feet of slope and shall be a minimum of 10 feet wide. This best management practice was not followed on the Mills-Wetzel site.

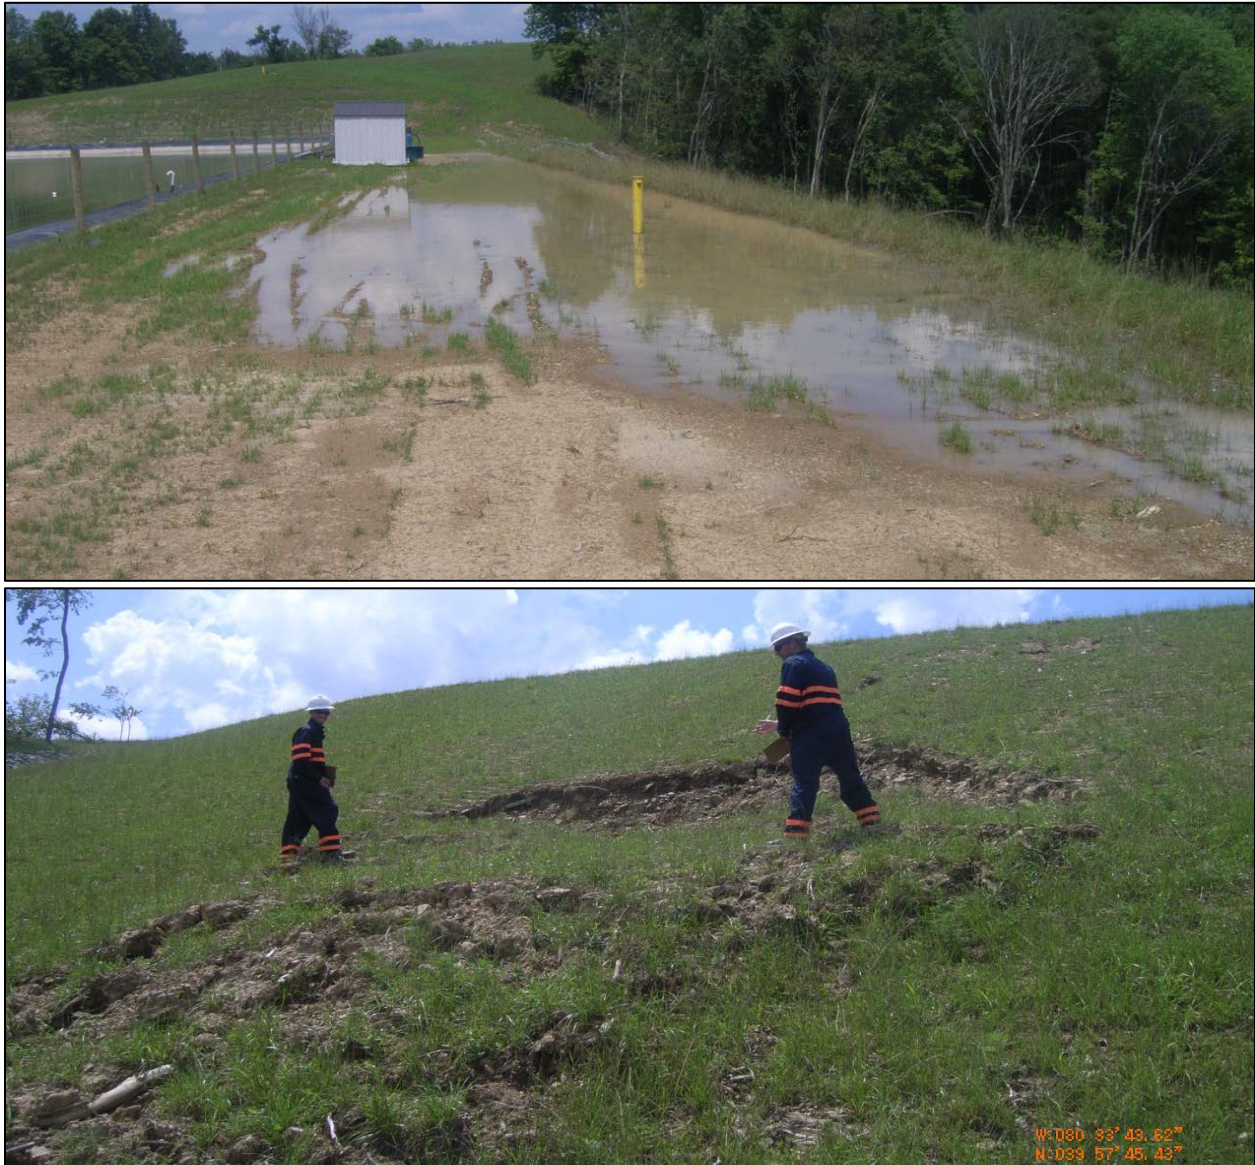
Figure 13: Slope Movement at SHL 4

Question 2 on the checklist related to the prevalence of slope movements on the downstream face. Two sites were found to have moderate slope movements, and severe slope movements were present on six sites. Figure 13 shows a severe slope movement on the SHL 4 Centralized Pit. Above the slope movement, there was a significant amount of standing water on the crest, and signs of seepage were found in the form of wet soil inside the depleted soil zone. Slope movements are a problem because the structural integrity of the downstream face has been compromised. This slope failure is an example of a shallow face failure with characteristics including a pronounced scarp, zones of depletion and accumulation, and flanks defining the width of the failed soil, which is approximately where the WVU field personnel are located.

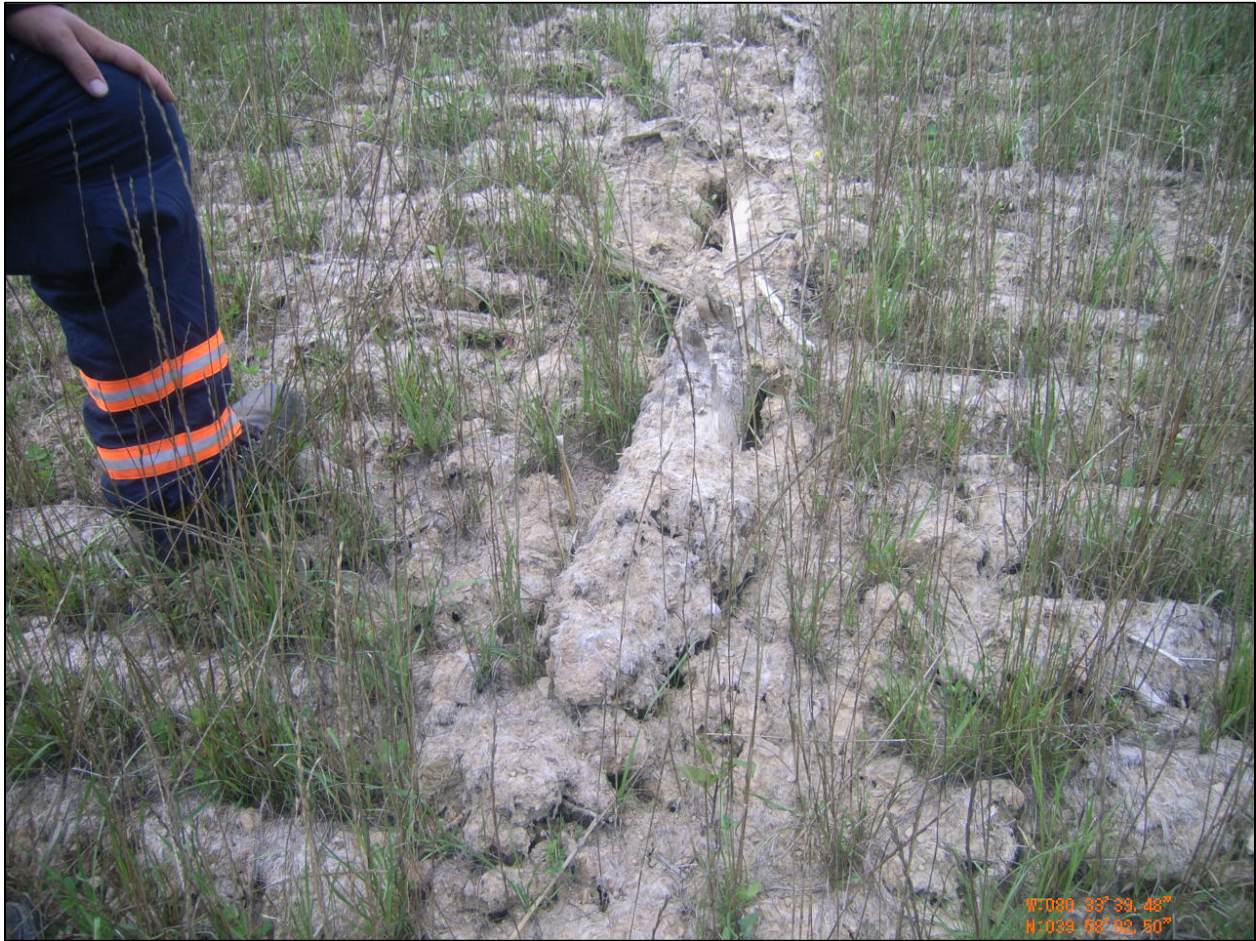
Figure 14: Woody Debris at SHL 2

Question 5 was used to evaluate any observed trees, tall weeds, or other vegetation, but the most prevalent concern was woody debris found in the fill of the slopes on all but two sites. Figure 14 depicts one instance of woody debris found on the SHL 2 Centralized Pit, where a log was compacted into the fill material on the downstream face of the pit. Woody debris is a problem due to the complications that may arise over time. One possible consequence is that the woody debris may form a barrier preventing the infiltration of water into the soil, causing erosion around the woody debris and on the slope directly below the debris. Another possible consequence is that the decomposition of the woody debris may result in pathways for surface water to seep into the slope, which reduces slope stability.

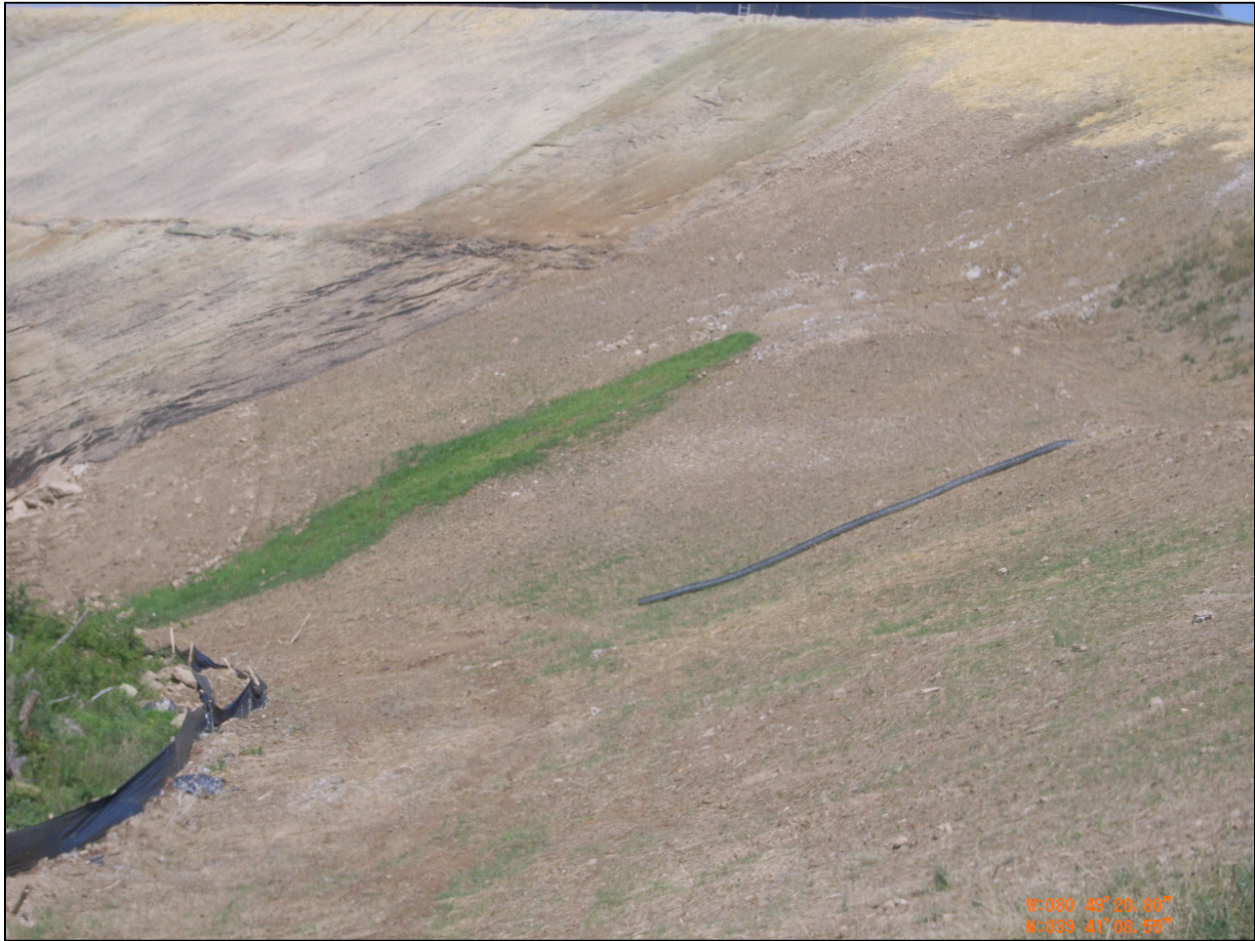
Figure 15: Seepage at Pribble

Seepage and wet zones (addressed in Question 6) were problem areas found at all but two sites. Figure 15 shows a seepage area on the downstream face of the Pribble Freshwater Impoundment. Due to the lack of vegetation on the slope, the area where the grass is growing depicts seepage and moving water on the slope. Thus, water is being transported through the soil, which may lead to instability in this area.

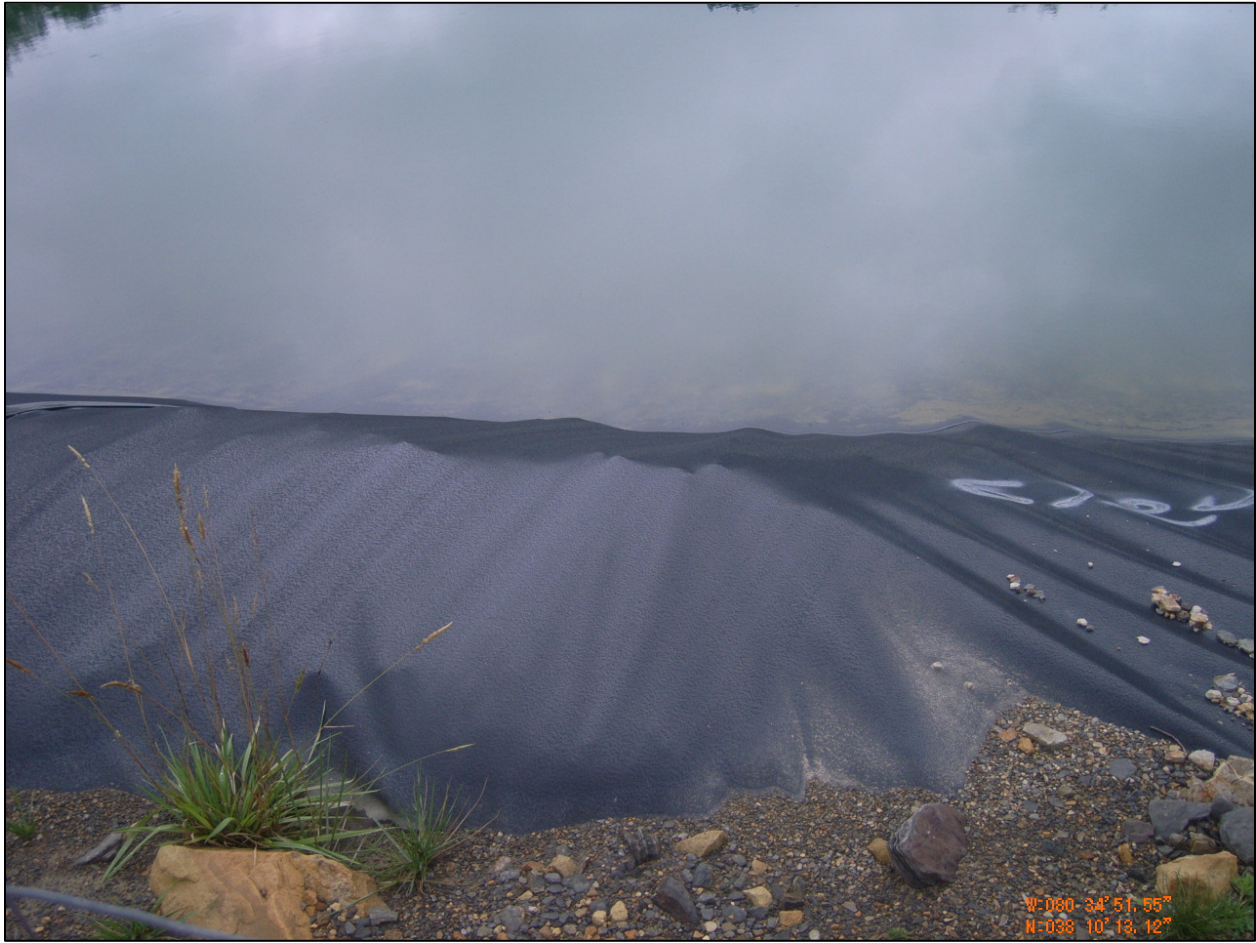
Figure 16: Liner Bulges at MWV

Another area of concern was bulges, tears, or holes in the liner, as indicated by Question 8. This problem was present at every site evaluated, with seven sites ranked as Low, four ranked as Moderate, and three ranked as High. Figure 16 depicts a liner stretched over an improperly prepared slope at the MWV Large Water Storage Pond 1. The underlying rock pressing on the liner and the strain caused by the bulges have a high likelihood to create tears or punctures in the liner and threaten the integrity of the containment system.

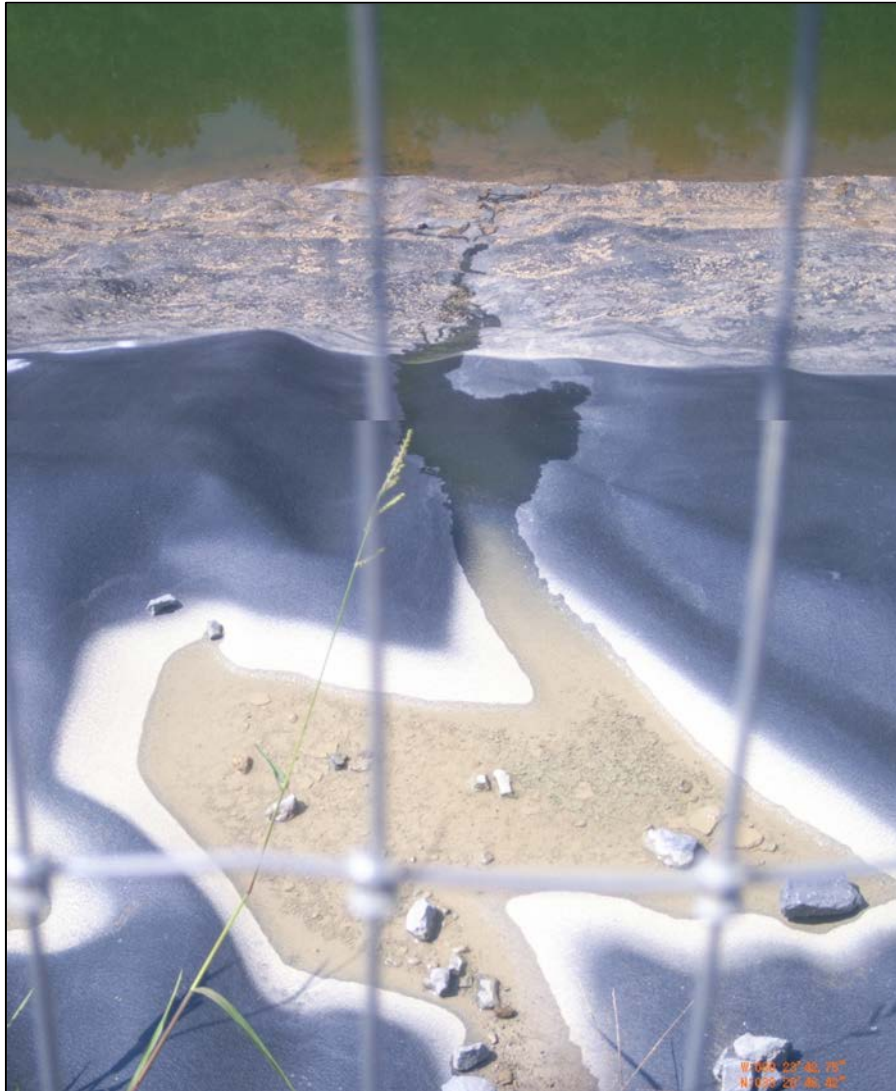
Figure 17: Debris on Liner at Flanigan

Question 10 involved the presence of rock or debris on top of the liner. This problem was observed at all sites except one. Figure 17 illustrates an example of a severe case of debris on the liner at the Flanigan Pit. At the Flanigan Pit as well as other sites visited, surface water was present on the berm and in the anchor trench. This practice is not in accordance with the West Virginia Erosion and Sediment Control Field Manual, which states that surface water must be diverted from the pit. The water washing the rock and debris into the pit adds weight to the containment system which can lead to strain and dislodgement of the anchor trench. Also, with the rock washing down over the liner, there is a higher potential for tears to form.

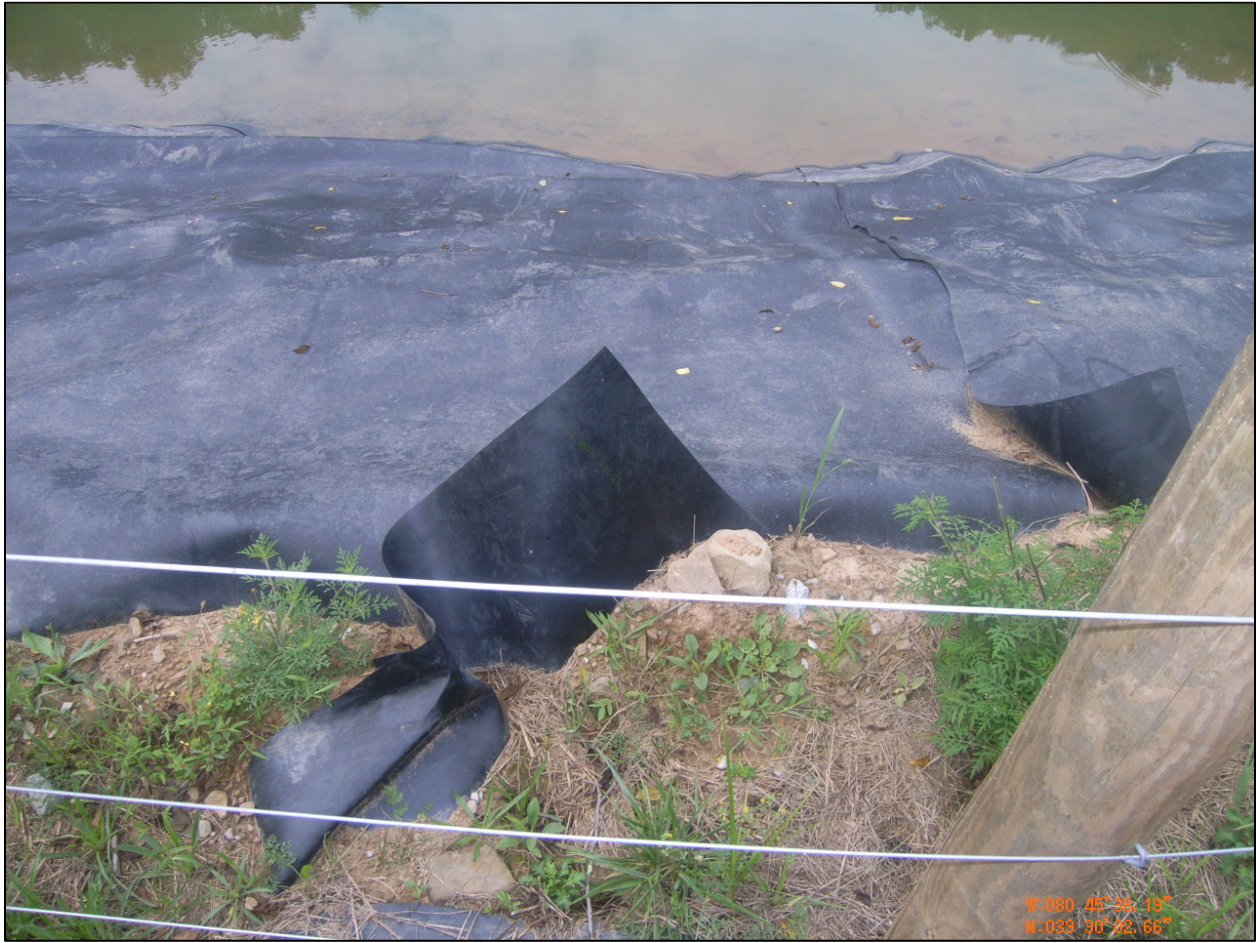
Figure 18: Improper Anchor Trench Embedment at Ball 1H

Deformations, cracks, and settlements around the anchor trench affect the integrity of the liner, and these concerns were addressed in Question 12 of the observation checklist. During field evaluations, this question was expanded to include the embedment of the anchor trench. All sites with the exception of one were found to have issues related to the anchor trench. Figure 18 illustrates improper anchor trench embedment at the Ball 1H Impoundment #2, as indicated by the liner protruding out of the ground. Improper embedment may result in an increased likelihood of the anchor trench pulling out of the soil, affecting the ability of the liner to retain fluids. Another potential issue is the possibility of wind lifting the liner and causing tears leading to a failure of the containment system.

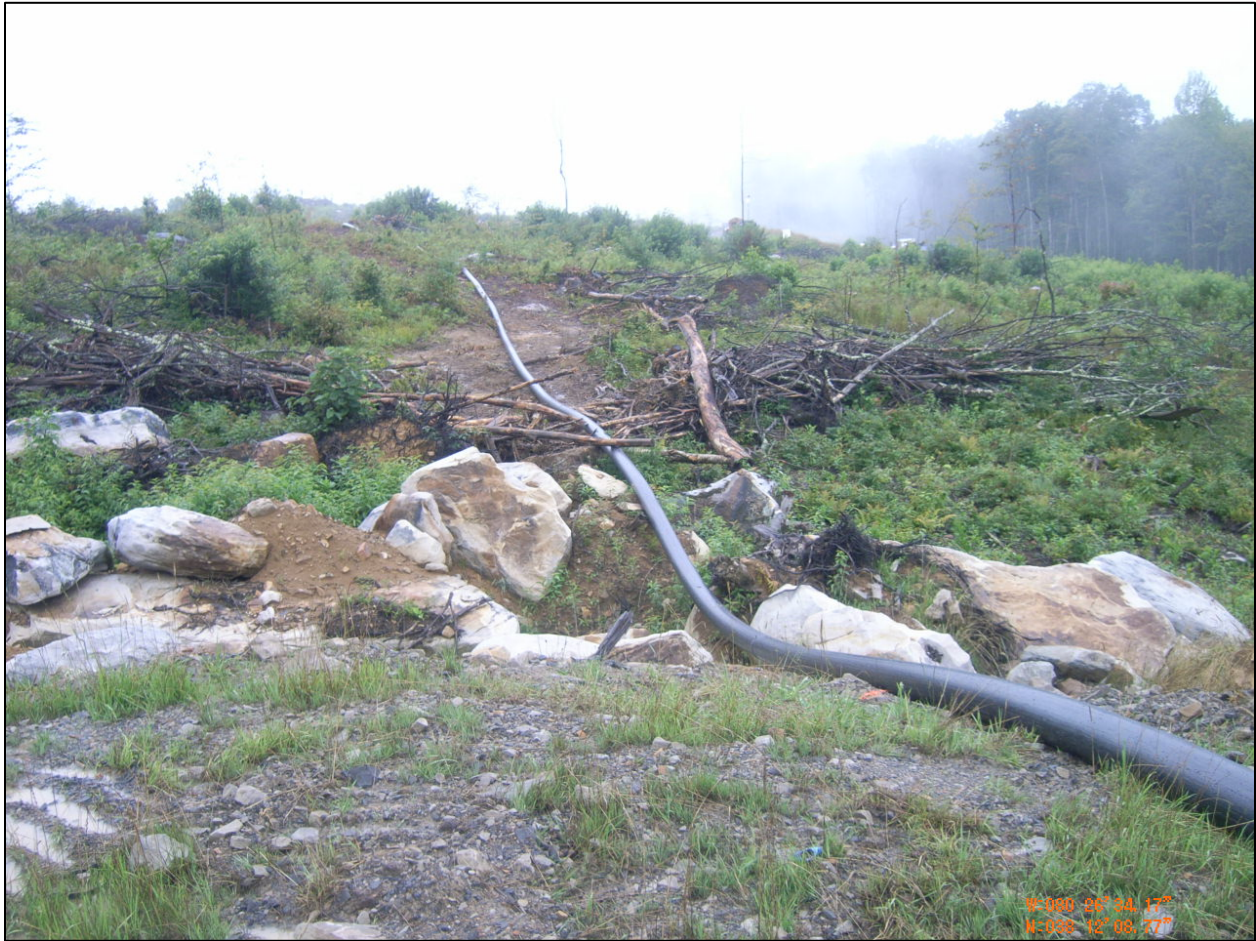
Figure 19: Unsupported Pipe at Plum Creek

The last observed trend was unsupported pipes. Question 14 addressed this concern, and pipes were not properly supported on eight of the fourteen sites. Figure 19 depicts a severe instance at the Plum Creek South Fork Impoundment. At this site, the pipe was unsupported along the crest of the impoundment and the adjoining hillside, hanging across a depression. Associated areas of concern include the pipe having the freedom to roll or slide, the possibility of the pipe buckling or pinching and restricting flow, and the increased potential for gouges and leakage. Any leakage or rupture of the pipes which convey water or flowback fluids would have an environmental impact to the surface water and groundwater.

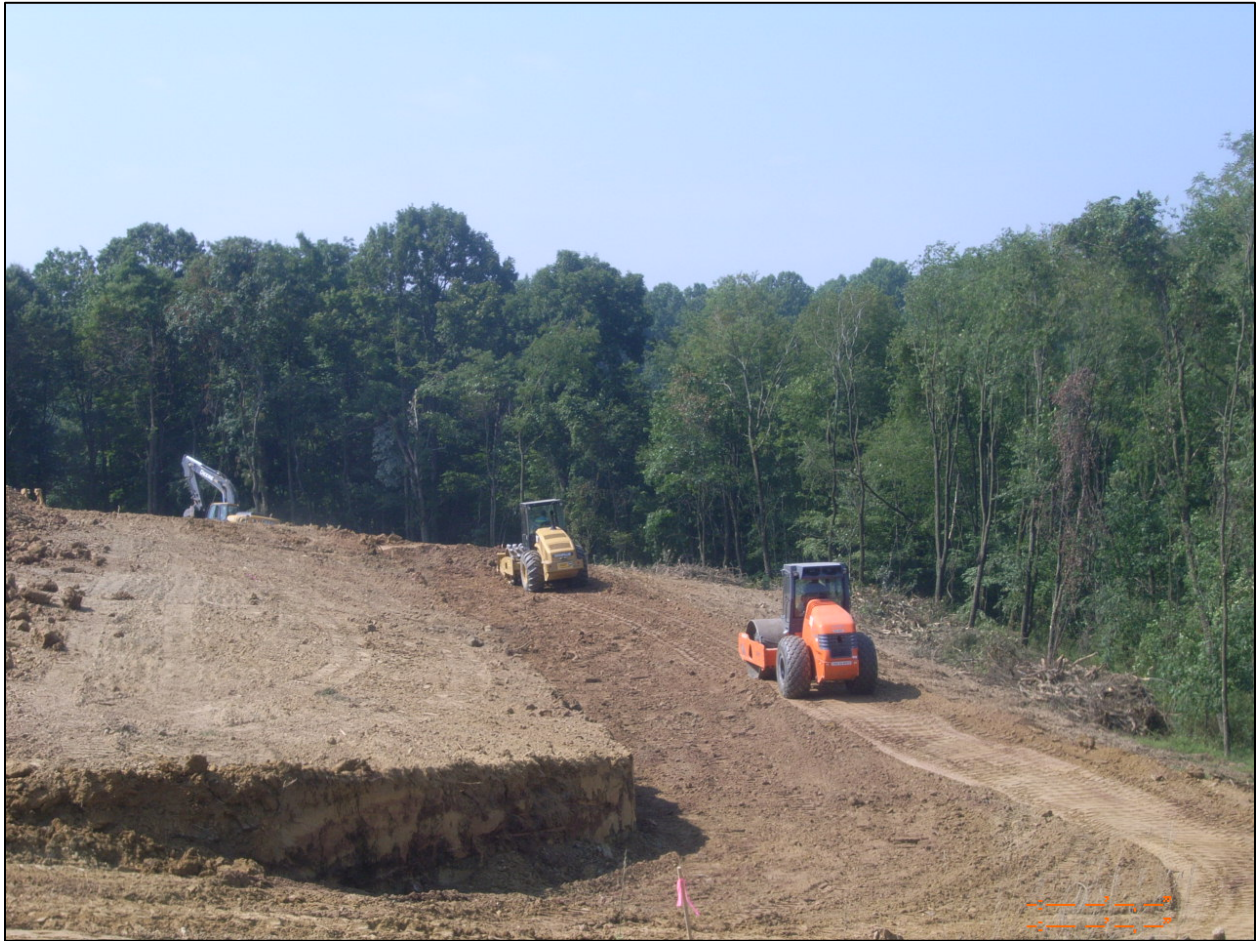
Figure 20: Improper Compaction Practices

In Figure 20, the excavator is placing the lift of soil, and the lift is being compacted by a sheep's foot roller, followed by a vibratory roller. According to the West Virginia Erosion and Sediment Control Field Manual, each lift shall be compacted by compaction equipment, sheep's foot or pad roller, with compaction to visible non-movement of the embankment material. Thus, the use of both a sheep's foot roller and a vibratory roller violates the best management practice in the manual. This construction practice is creating a shear plane on which water can move through the soil, possibly resulting in a slope failure. The sheep's foot roller kneads the soil, interlocking the soil lifts and benefiting compaction efforts, but the vibratory roller is negating this interlocking by smoothing the soil.

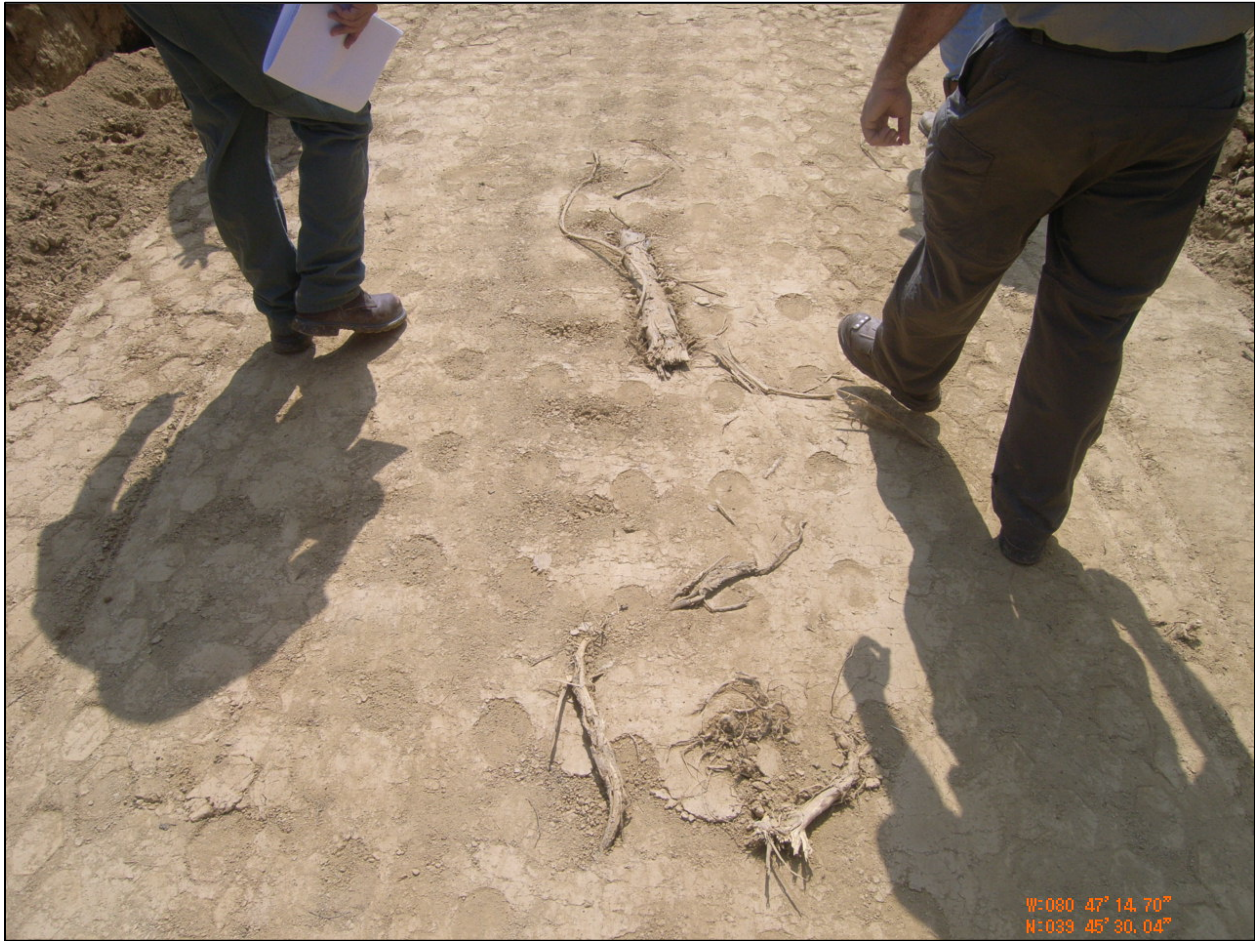
Figure 21: Woody Debris in Soil Lift

Figure 21 depicts woody debris that has been compacted into the fill, which was a recurring area of concern on a majority of the sites evaluated. The West Virginia Erosion and Sediment Control Field Manual states that the fill material shall be clean mineral soil, free of roots, woody vegetation, stumps, sod, large rocks, or other objectionable material. As Figure 21 shows, this best management practice is not being followed at the Shields FWI site. Organic material compacted into the fill may create pathways for water to infiltrate the soil and cause internal erosion, which is a possible failure mode for the structure.

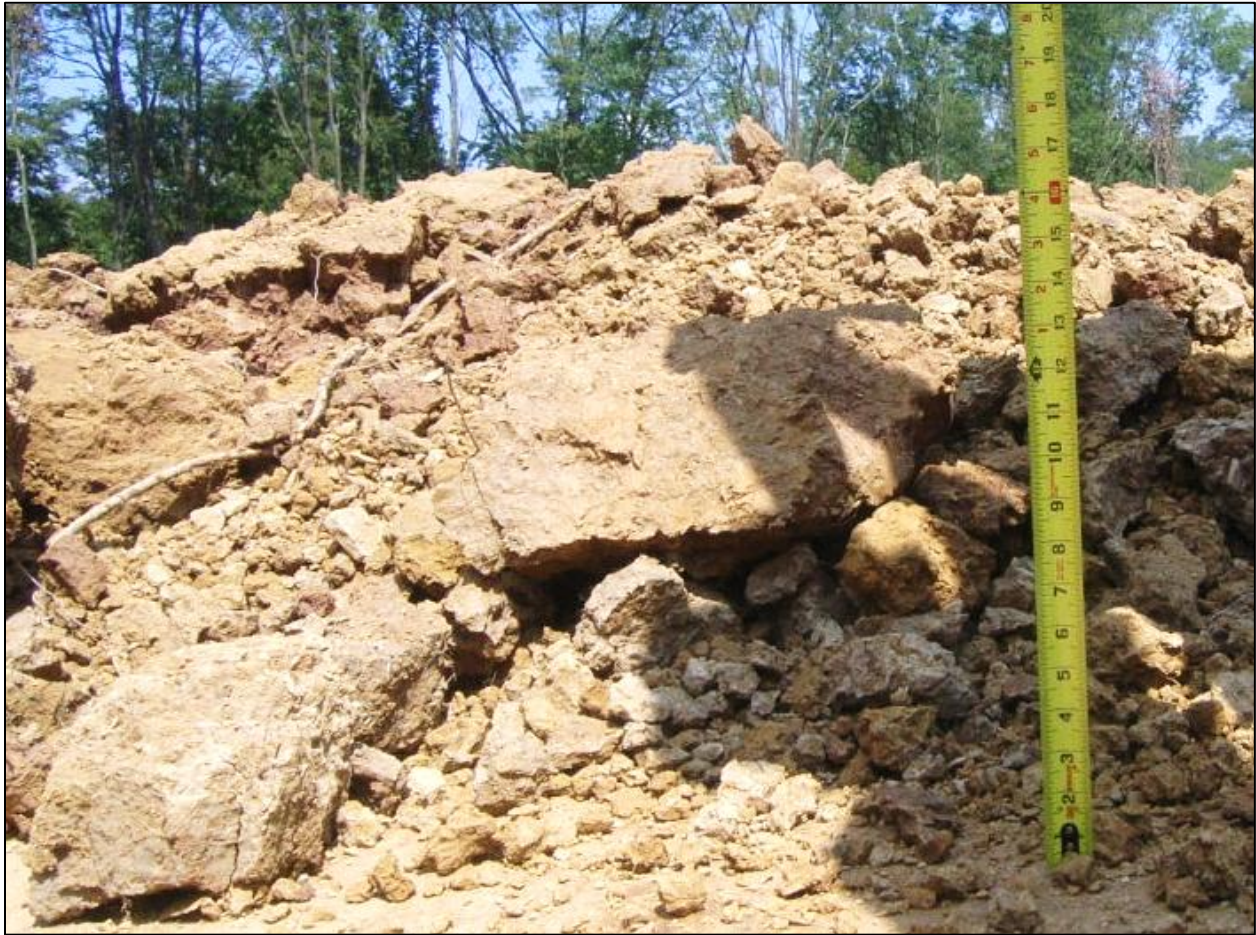
Figure 22: Excessive Lift Thickness

According to the West Virginia Erosion and Sediment Control Field Manual, soil lifts must be as thin as the suitable random excavated material will permit, typically from 6 to 12 inches. In Figure 22, the lift thickness is 16 inches, so this construction practice is not in accordance with the best management practice specified in the manual.
