Pits and Impoundments Final Report

Assessing Environmental Impacts of Horizontal Gas Well Drilling Operations (ETD-10 Project)

Prepared for:

December 17, 2012

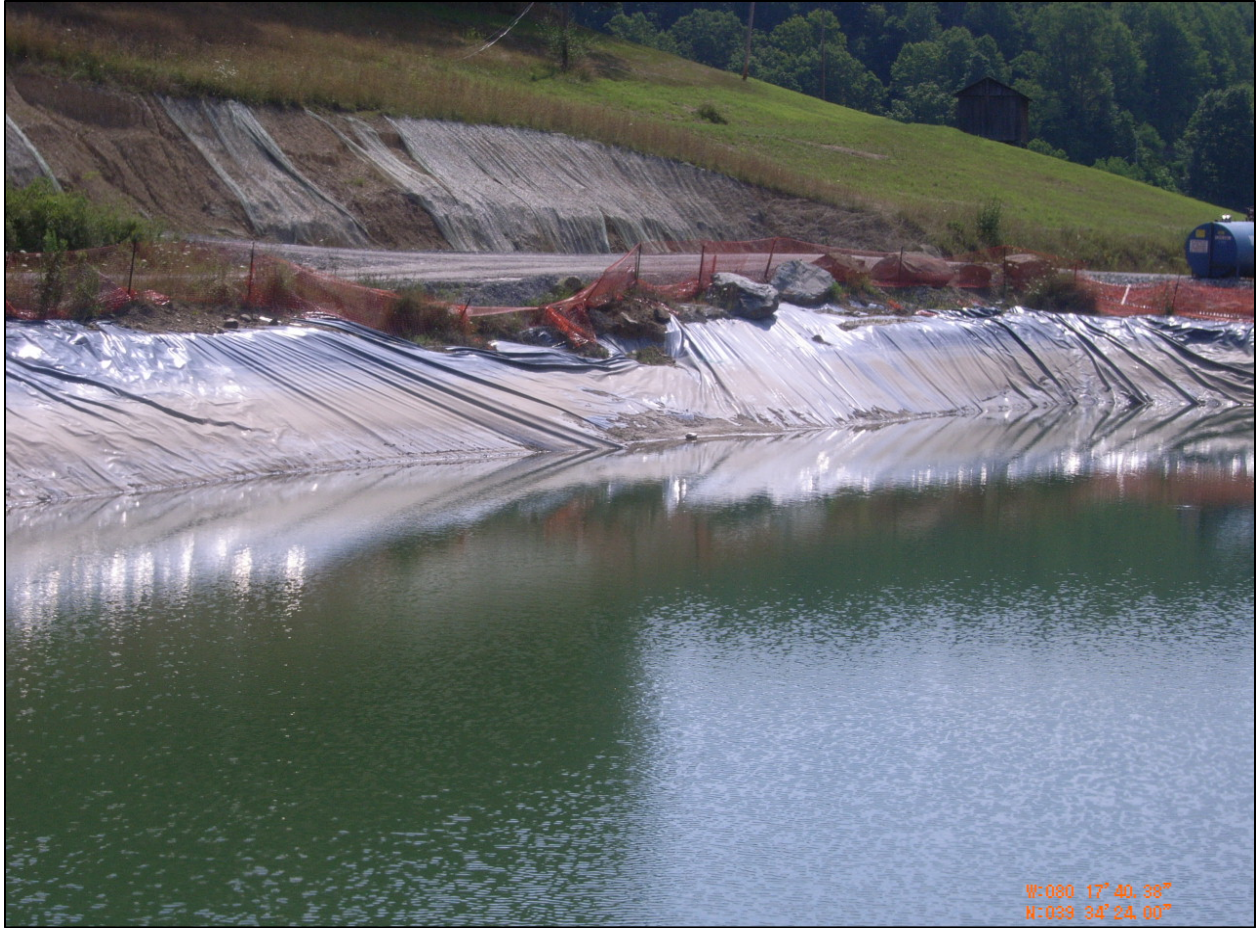
Figure 6: Slope Movement into Impoundment

Figure 6 depicts a slide into the impoundment. This slide is putting strain on the liner, endangering the anchor trench and increasing the tear potential for the liner. Additionally, the slide is just below the site access road and is thereby threatening the integrity of the roadway. The displacement of the liner threatens the entire containment system due to an increased potential for tears or punctures leading to impounding water loss.

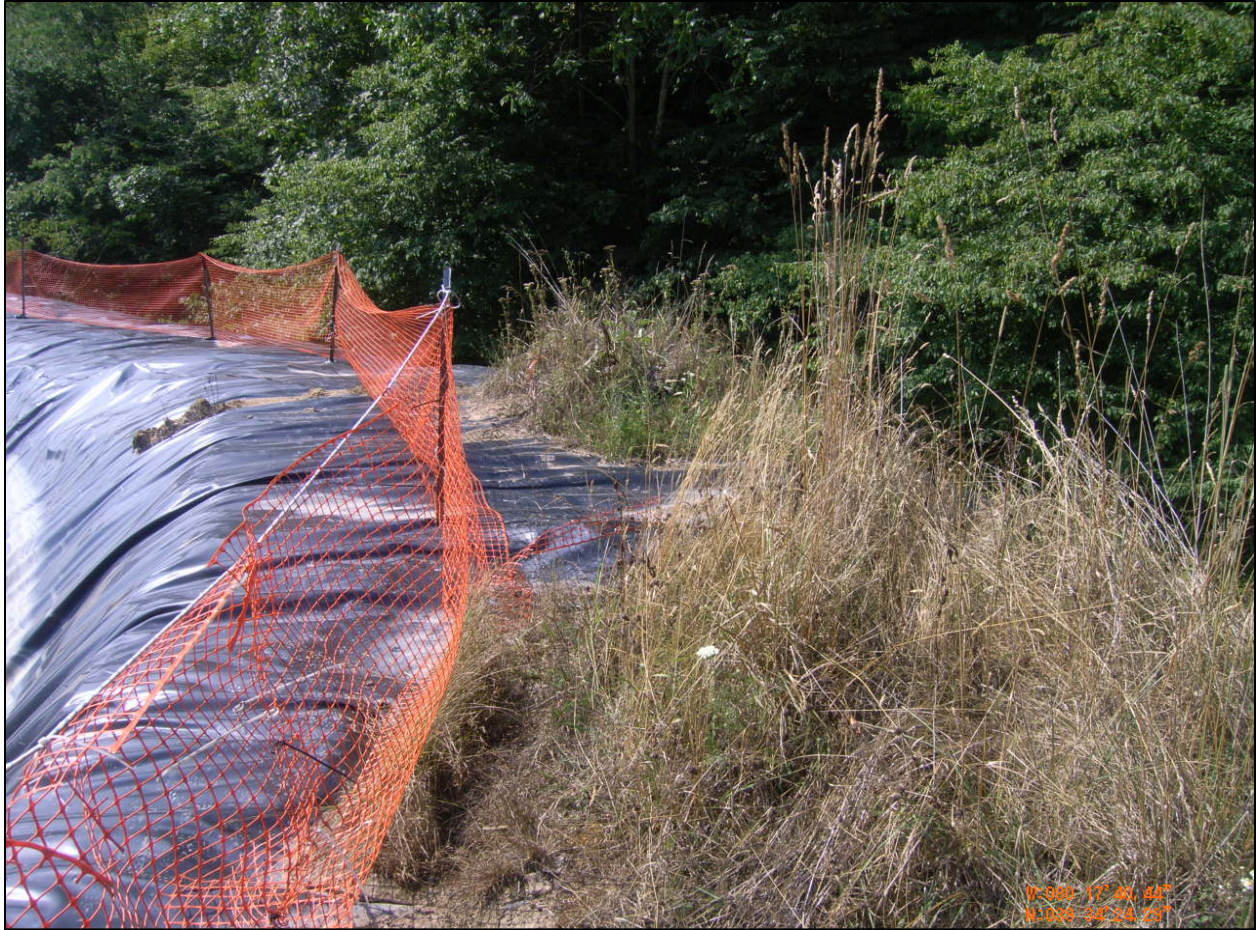
Figure 7: Vegetation on Berm

The vegetation shown in Figure 7 poses a problem for inspection procedures. The excessive vegetative growth on the crest may conceal potential areas of concern. Thus, corrective actions may not be implemented at an appropriate time.

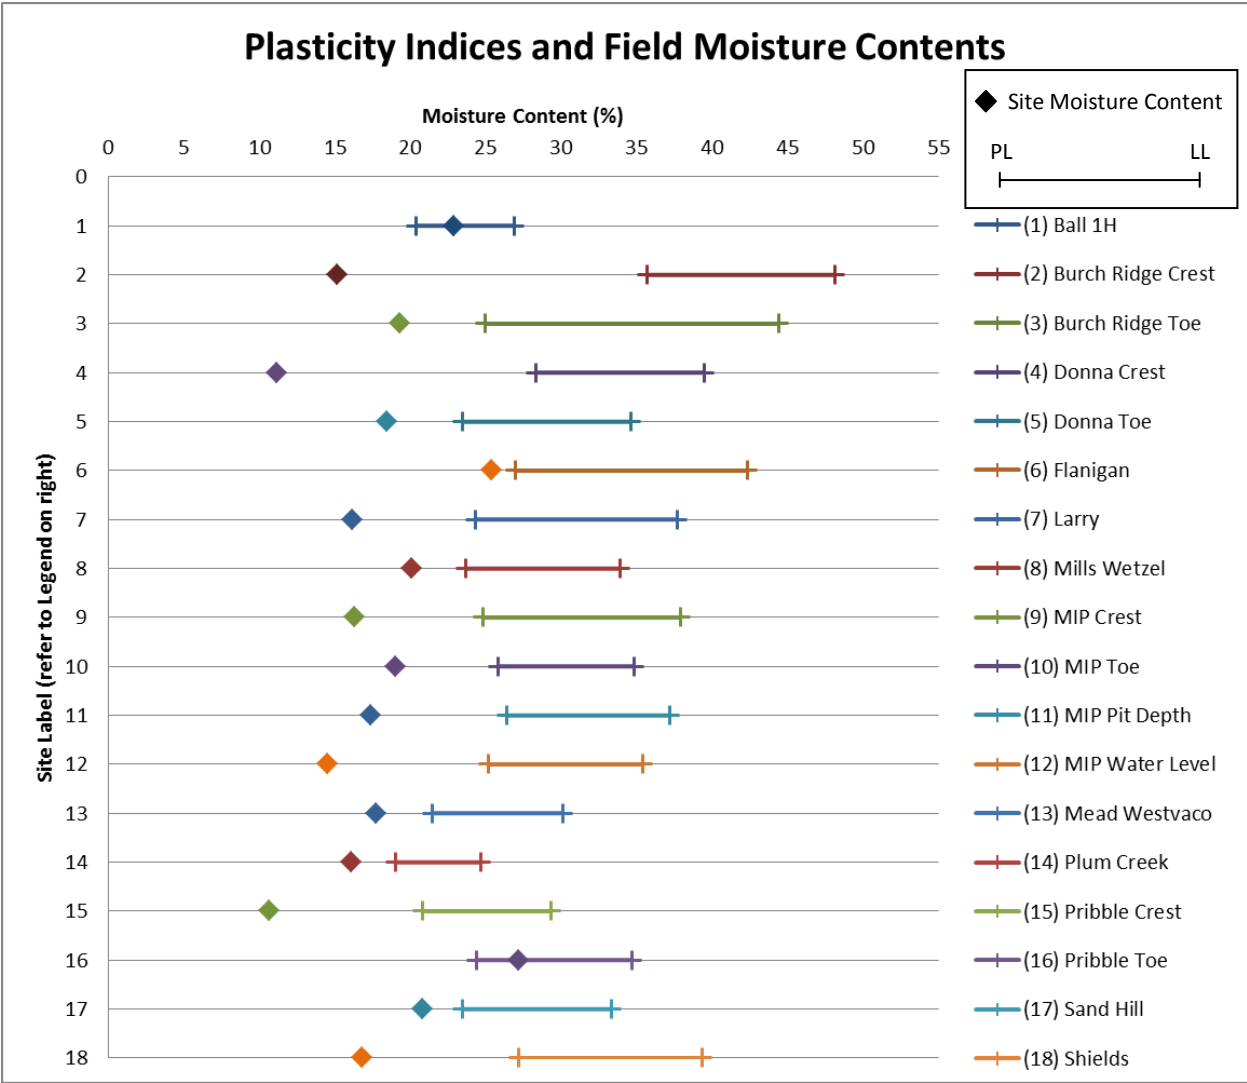
Figure 23: Atterberg Limits and Field Moisture Content

Once the laboratory testing was completed, the results from the various tests were compiled into tables and graphs in order to present the results in a convenient manner. Figure 23 illustrates the results of the Atterberg limits testing for each site. The range of moisture content values between the Plastic Limit (PL) and Liquid Limit (LL) is shown for each site, and the field moisture content is graphed as an illustration of the soil condition at the site. These values are displayed numerically in Table 7, where the results from the grain-size distribution and Atterberg limits tests for each site were used to classify the soil according to the ASTM D2487 Standard. According to the WVDEP Design and Construction Standards for Centralized Pits, the following soil classifications are acceptable for post §22-6A sites: Clayey Gravel (GC), Silty Gravel (GM), Clayey Sand (SC), Silty Sand (SM), Clay (CL), and Silt (ML). The laboratory testing results indicated that none of the post §22-6A sites met this requirement, and of the remaining 12 pre §22-6A sites, only one site met the soil standards.

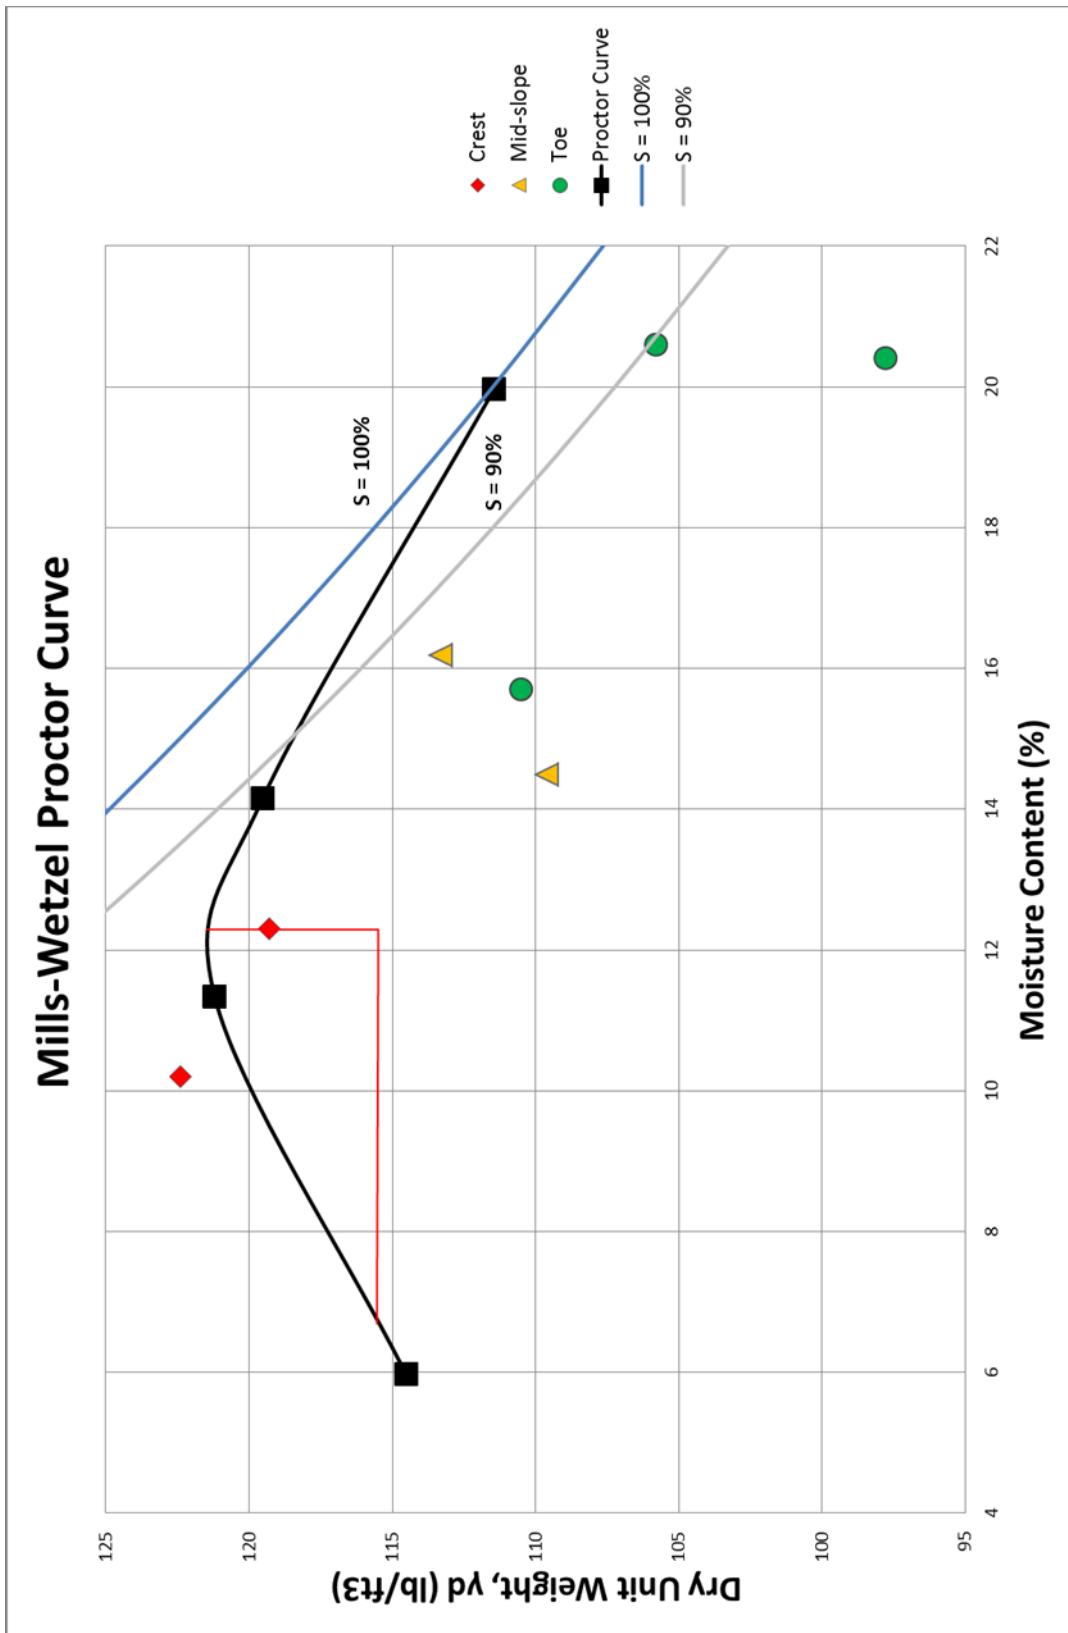
Figure 24: Mills-Wetzel Compaction

The compaction results show that the soils on the crests tended to be overcompacted, which would render the point on the wet side of optimum if compared with a higher compaction energy. Also, the soils at the mid-slopes and toes of the downstream faces were consistently under-compacted and contained moisture content values higher than optimum. As a result, the soils at these locations exhibited high saturation values. These conditions may result in lower unit weight and strength for the soil, leading to a higher potential for slope deformation, internal erosion, and seepage. These observations were found to be trends across all sites, as only three of the six sites contained data points within the appropriate compaction range. Only 14% of field data points were in compliance at two of the sites, and 22% were in compliance at the third site. Overall, a total of seventy data points were taken across all six sites, and only six points were within the acceptable compaction range, which corresponds to 8.5% compliance with WVDEP standards. Table 9 further illustrates these trends by comparing the optimum moisture content and density with the ranges observed in the field for each site. Based on these findings, the compaction practices at the sites evaluated do not conform to the best management practices specified in the West Virginia Erosion and Sediment Control Field Manual.

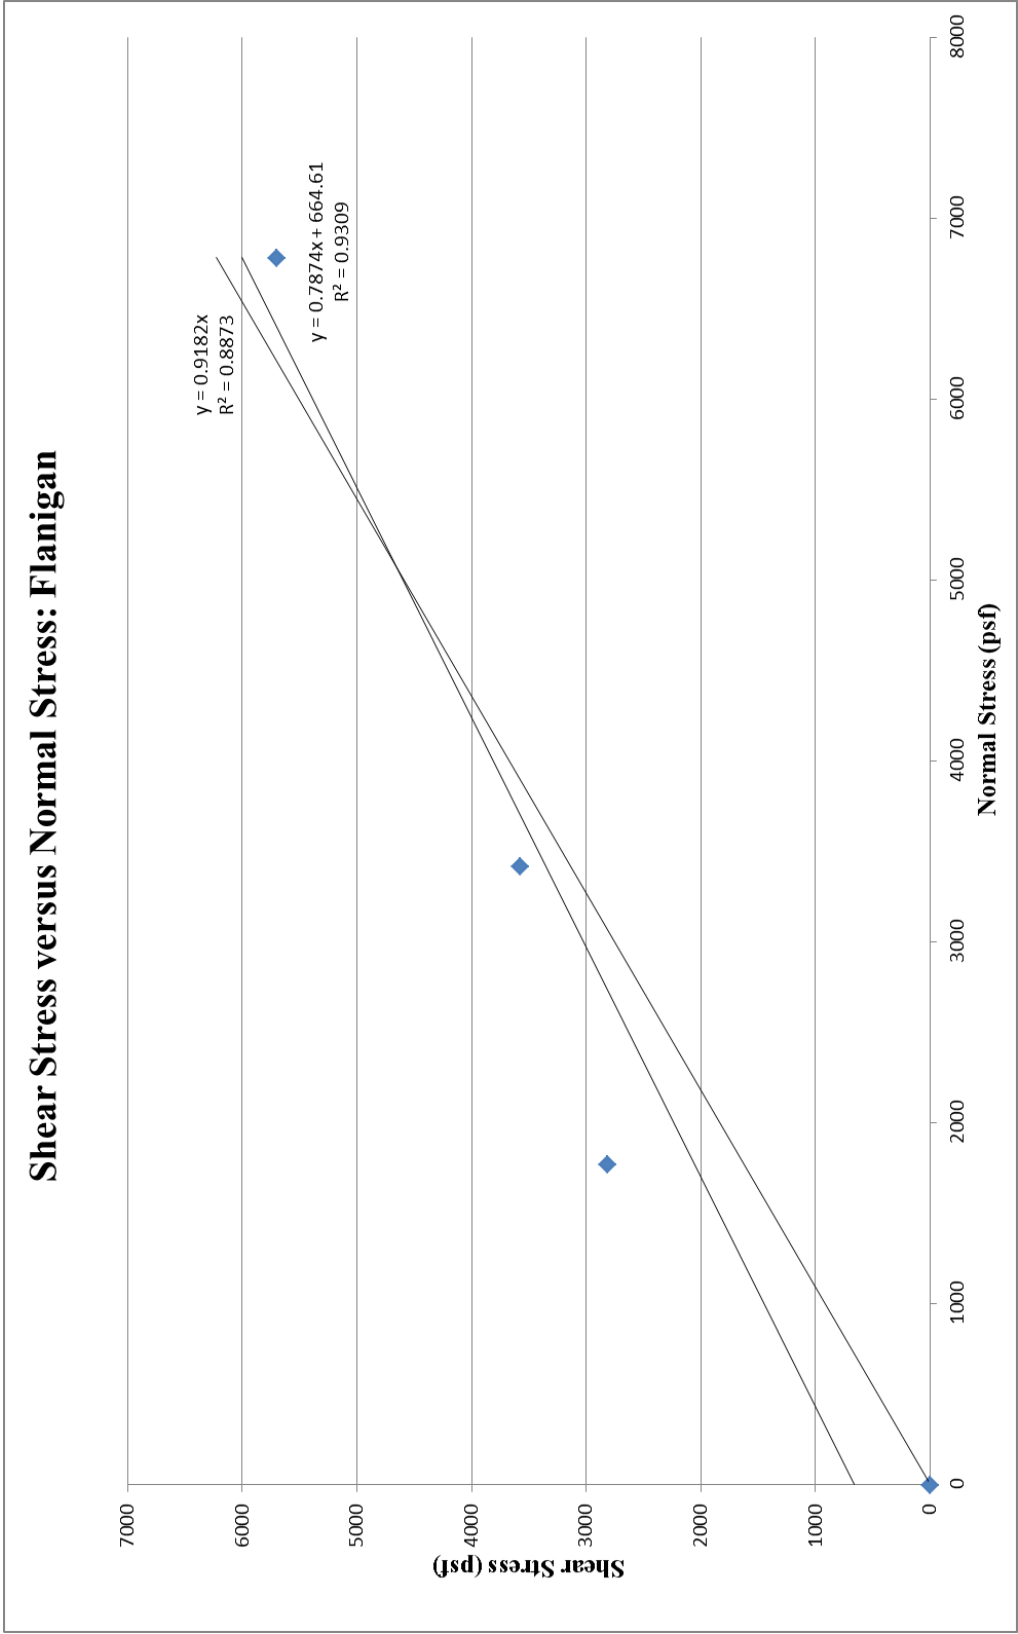
Max Shear Stress vs. Normal Stress (Flanigan)				
Date	Sample	Compaction	Material	
11/30/2012	Flanigan	25 Blows/Layer, 5 Layers	Passing No. 4	
Specimen Number	Max Shear Stress (ksf)	Max Shear Stress (psf)	Normal Stress (psf)	
High	5.703	5703	6786	
Medium	3.574	3574	3423	
Low	2.815	2815	1771	
4	0	0	0	
m	0.7874	m	0.9182	
ϕ' (degrees)	38.217	$\phi_{c=0}'$ (degrees)	42.558	
c' (psf)	664.610	c' (psf)	0.0
